Inspection Report
Minerals Regulatory Program
Report Date November 14, 2005

Mine Name: White Cloud
Operator Name: Sutherland Brothers, Inc.

Permit number: S/015/044
Inspection Date: September 12, 2005
Time: 3:40-4:20 PM

S/015/044, White Cloud Mine, Sutherland Brothers, Inc.

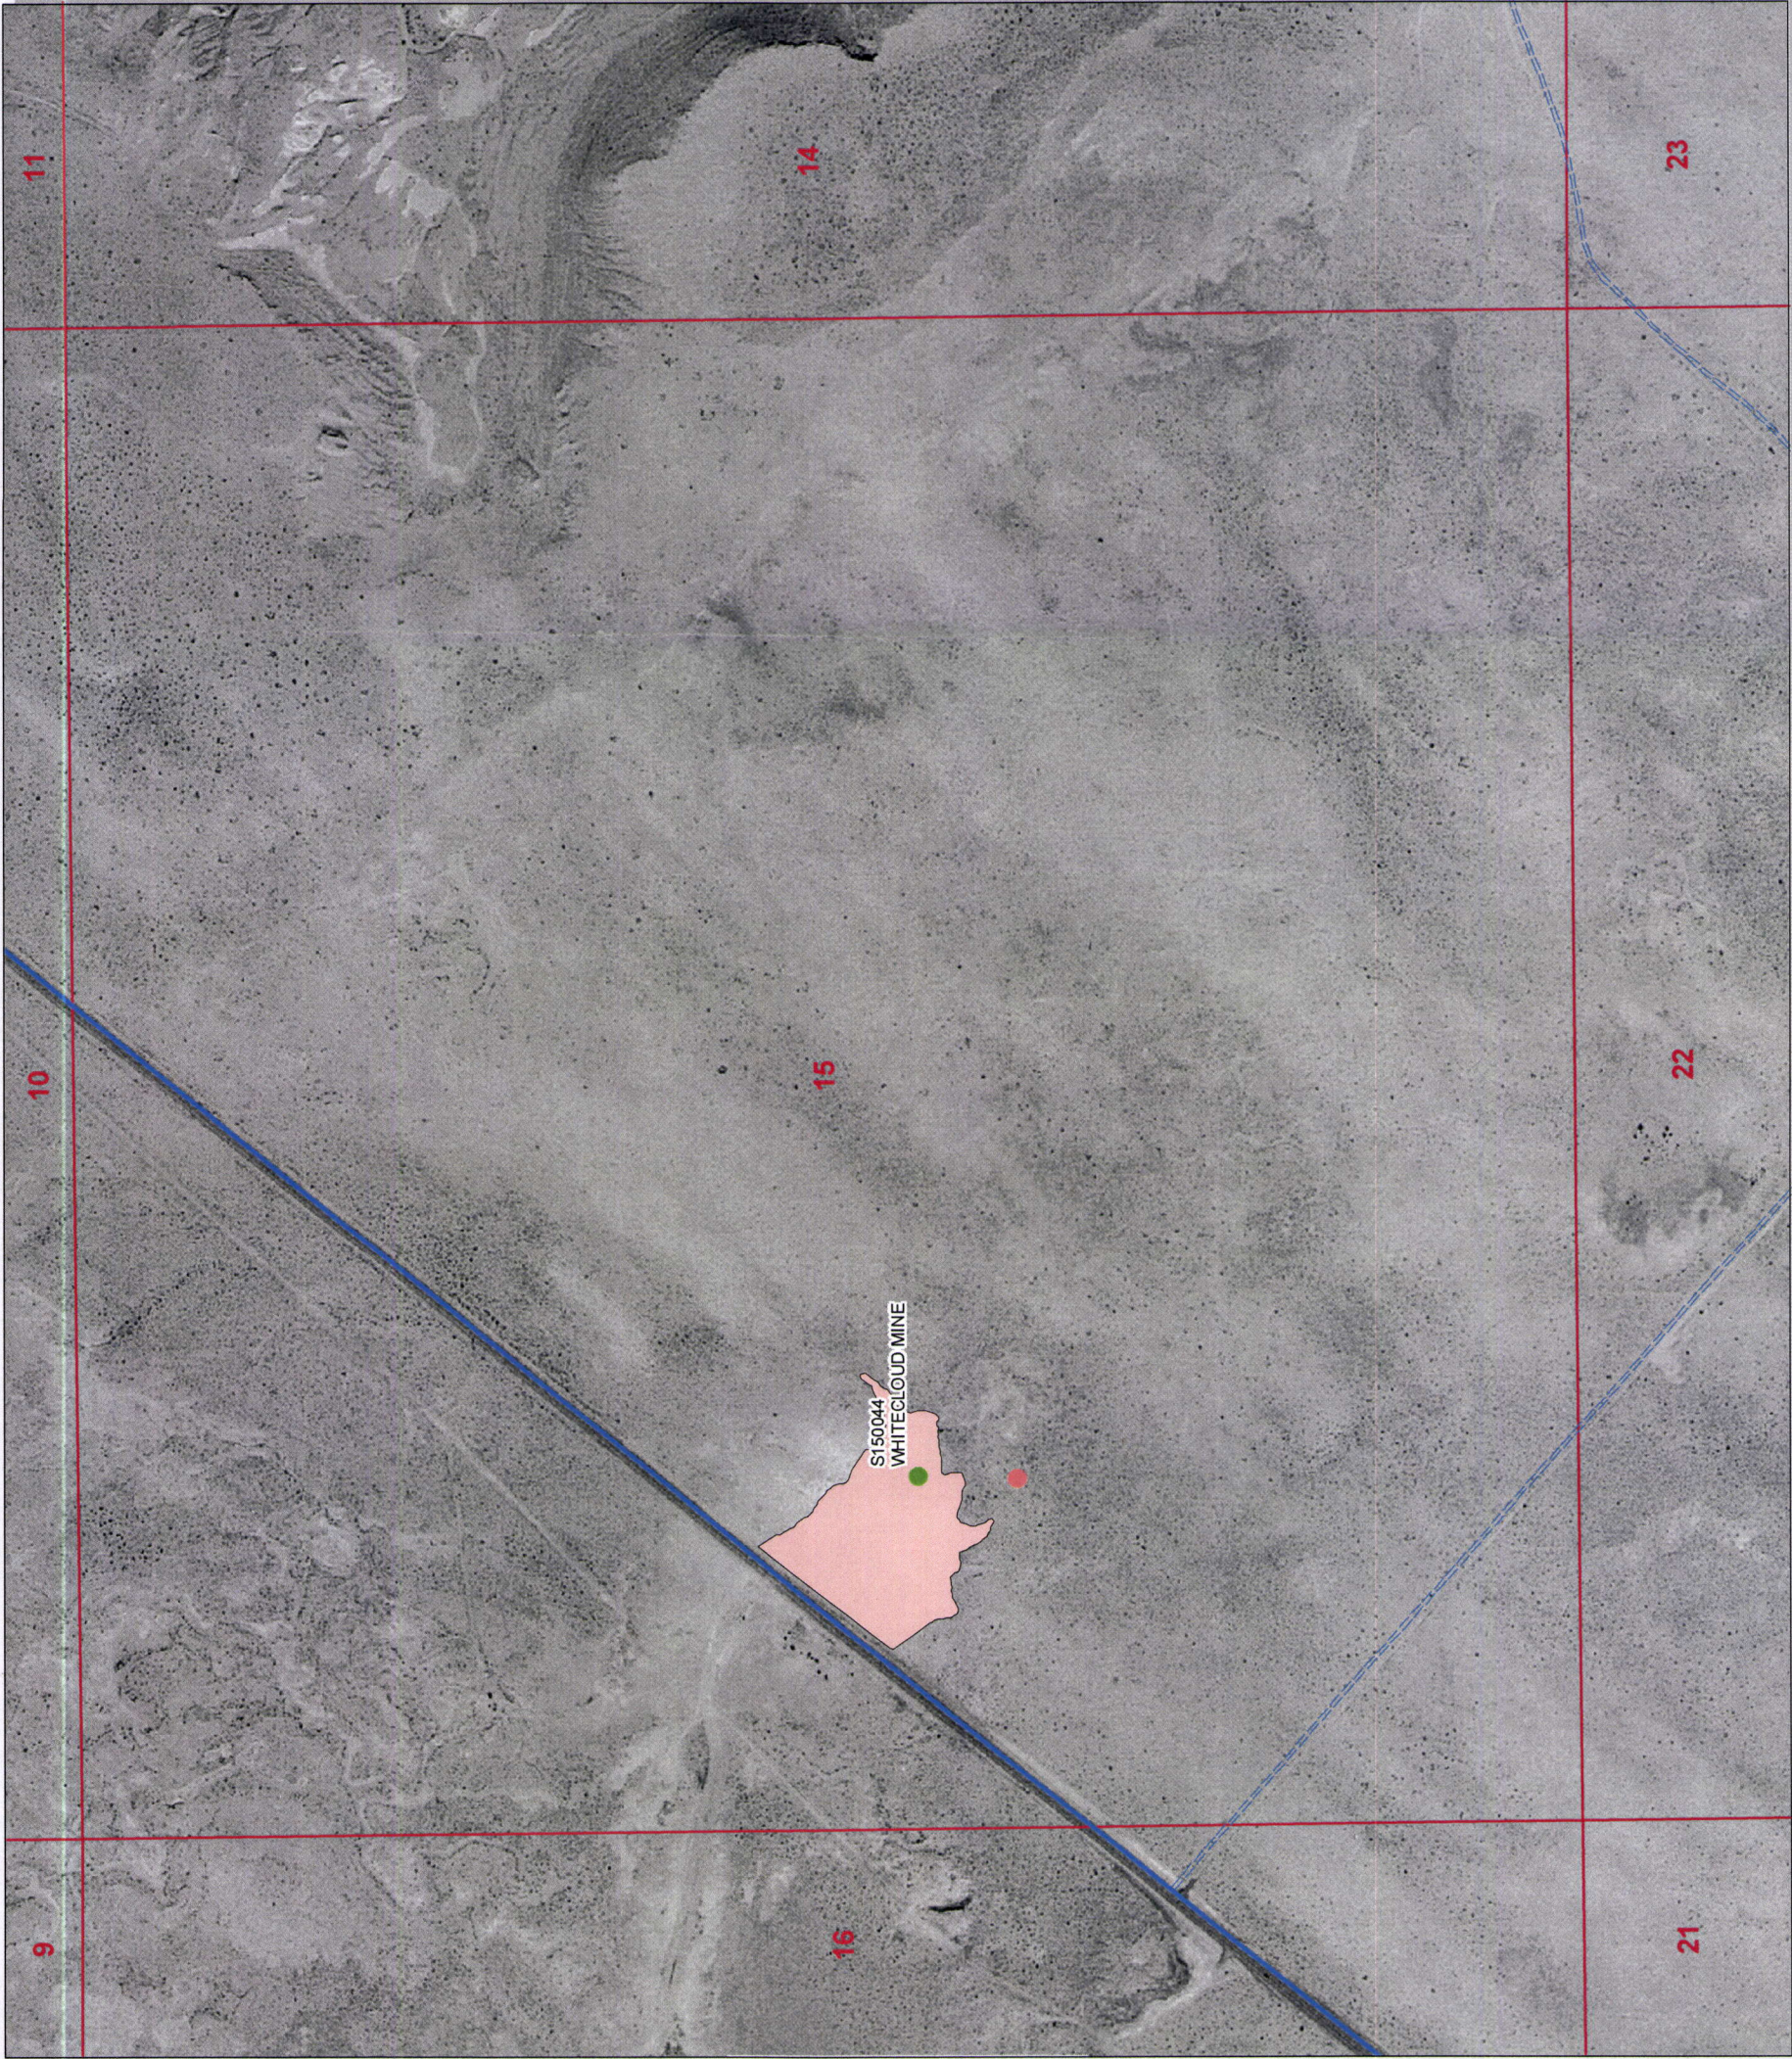
Mine Number: M0150044
Mine Name: Whitecloud Mine
Township 24 S Range 13 E Section 13 SLBM

I used a GPS unit in an attempt to map the site, and a copy of the map created from this data is attached. While I obtained a disturbed area acreage of 7.99 acres, this figure is not accurate. Because of the impounded water, I often could not tell where the edge of the disturbed area was, and there

were some places where I did not want to walk through the water or mud to follow the boundary. It is possible the windrow of overburden or soil is actually the northwestern edge of the mine, but I could not tell.

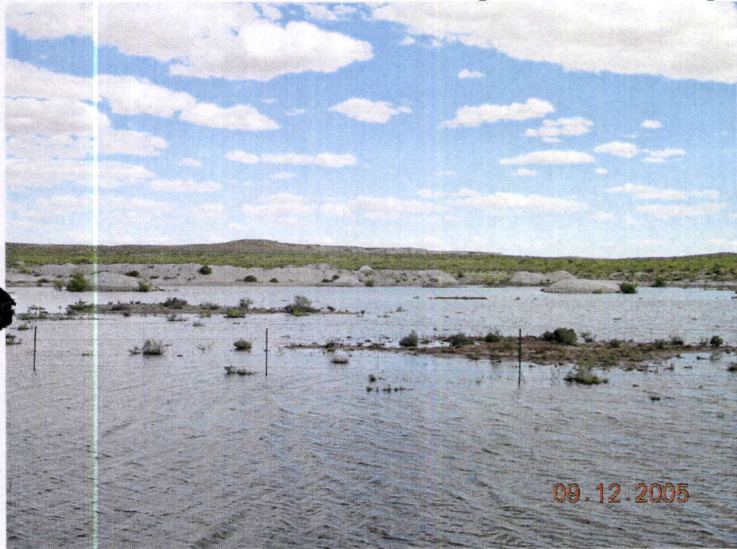
The area had recently had rain, and a large part of the disturbed area was under water. The highway serves as an impounding structure. There is a windrow of material across nearly the center of the site, but it is breached and would not impound water.

Photo 1 is a view of the site looking southeast from SR 24. All four photos show the non-continuous windrow of material through the middle of the site, and Photos 2 and 4 show a stockpile of what appears to be gypsum product. There are other piles of material around the site, including one that looked like manure. I assume the windrow may be either topsoil or overburden, but I am not certain.

Photo 1. This photo is looking approximately southeast toward the mine site from SR 24.

I recommend that the operator try to find a way to have water drain away from the area. The impounded water would make it nearly impossible to mine, but it also adversely affects the soil so it will be difficult to revegetate the site.

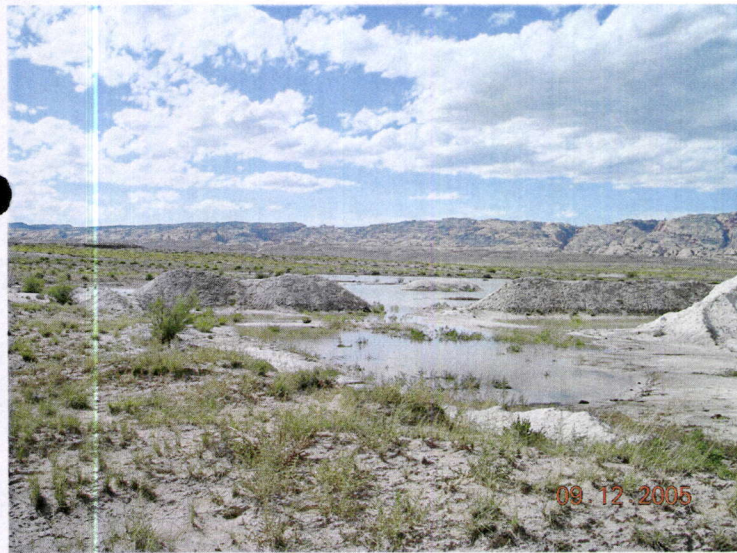
Photo 2. Looking west toward the San Rafael Swell. Note the windrow of material across the center of the photo and the stockpile in the center right.

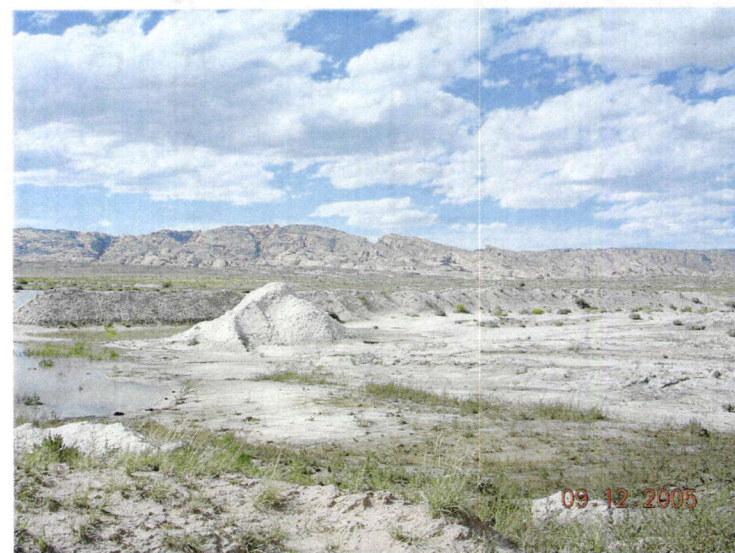
Photo 4. This picture and Photo 2 form a panorama.
